# **ACCELERATED MISSION TEST EVALUATION OF TF33 ENGINE COMPONENTS COATED WITH HIGH VELOCITY OXY-FUEL (HVOF) THERMAL SPRAY COATINGS IN LIEU OF HARD CHROME**

**Gary C. Shubert / Melvin Freling**  
**Program Managers**  
**Pratt & Whitney**

HCAT Program Review Meeting - April 2003  
San Diego, CA

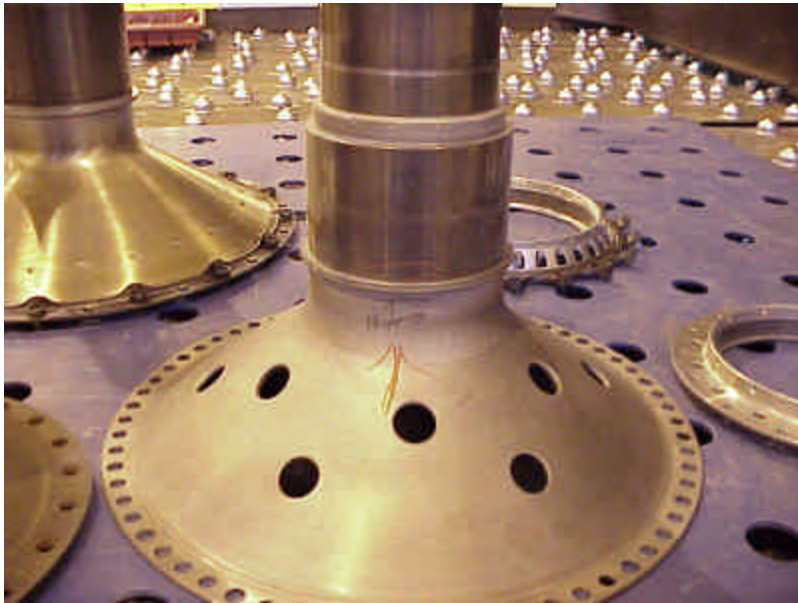
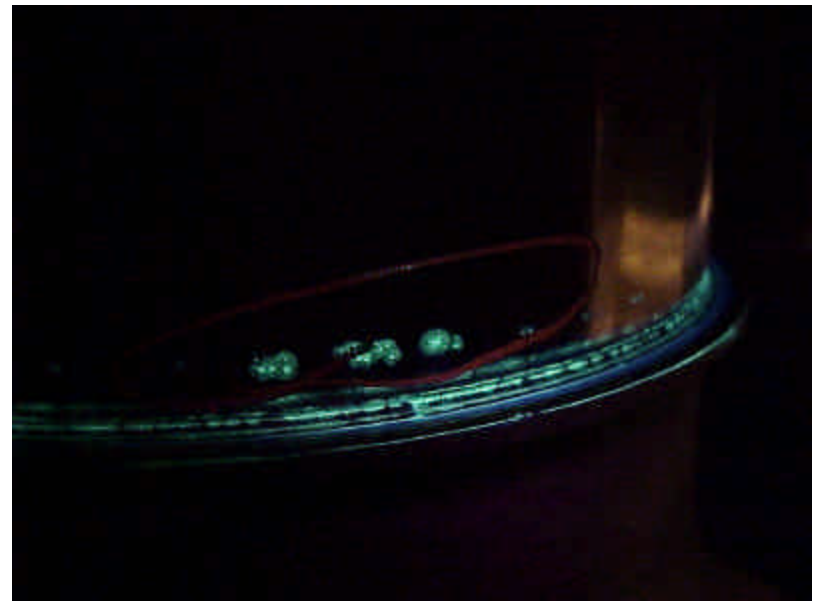
- FPI Inspection (Normal & High Sensitivity)
  - Various indications identified
- Dimensional Inspection
  - Coated areas changed in dimension by a maximum of  $\pm 0.0002$ "
    - All coated components met the dimensional requirements for continued engine service
- Metallographic Evaluation
  - Verified acceptable coating structures
  - Confirmed FPI indications
    - Indications due to coating finish grind

# No. 2 Bearing Journal FPI Indications Attributed to Coating Grind

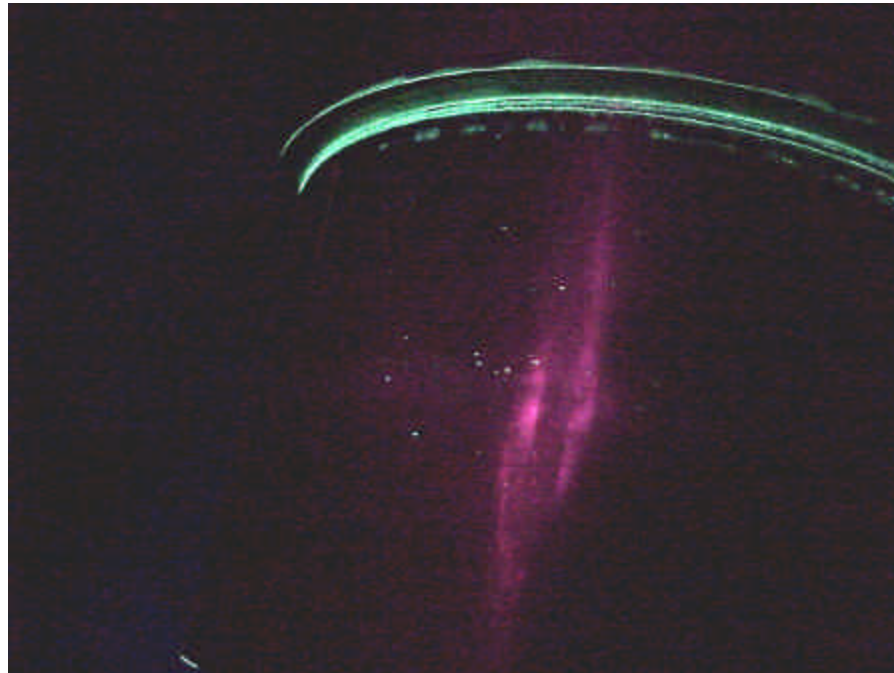
# No. 2 Bearing Journal High Sensitivity FPI Coating Indications Indicative of Carbide Pullout

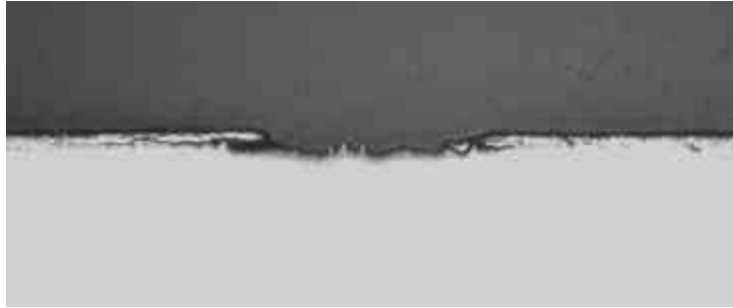
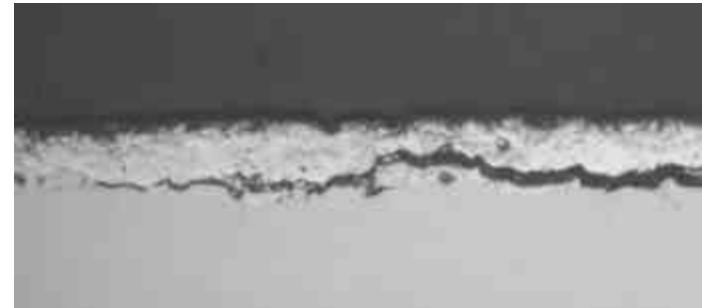
# Indications Attributed to Variations In As Ground Coating Thickness

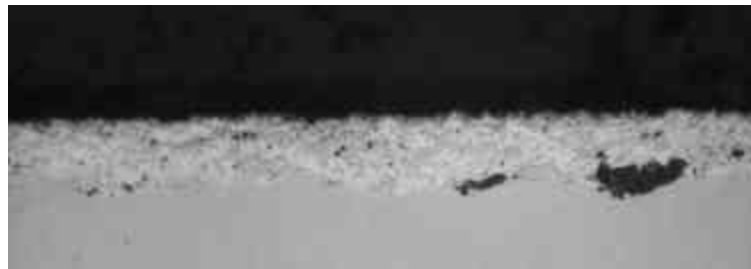
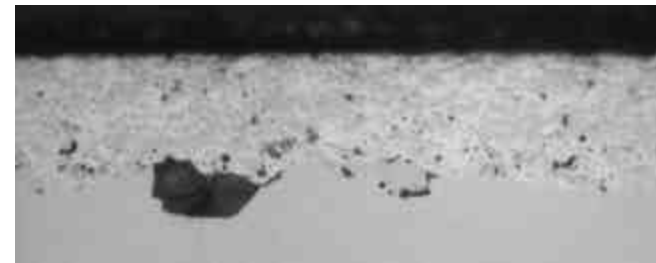
Front Compressor Rear Hub Showing Loss of Coating at FPI Indication (left) and Disbonded Coating Adjacent to Indication (right)

Front Compressor Rear Hub Showing Coating ~0.8 mils in Chatter Region (left) and ~1.8 Mils in Non Chatter Region (right)

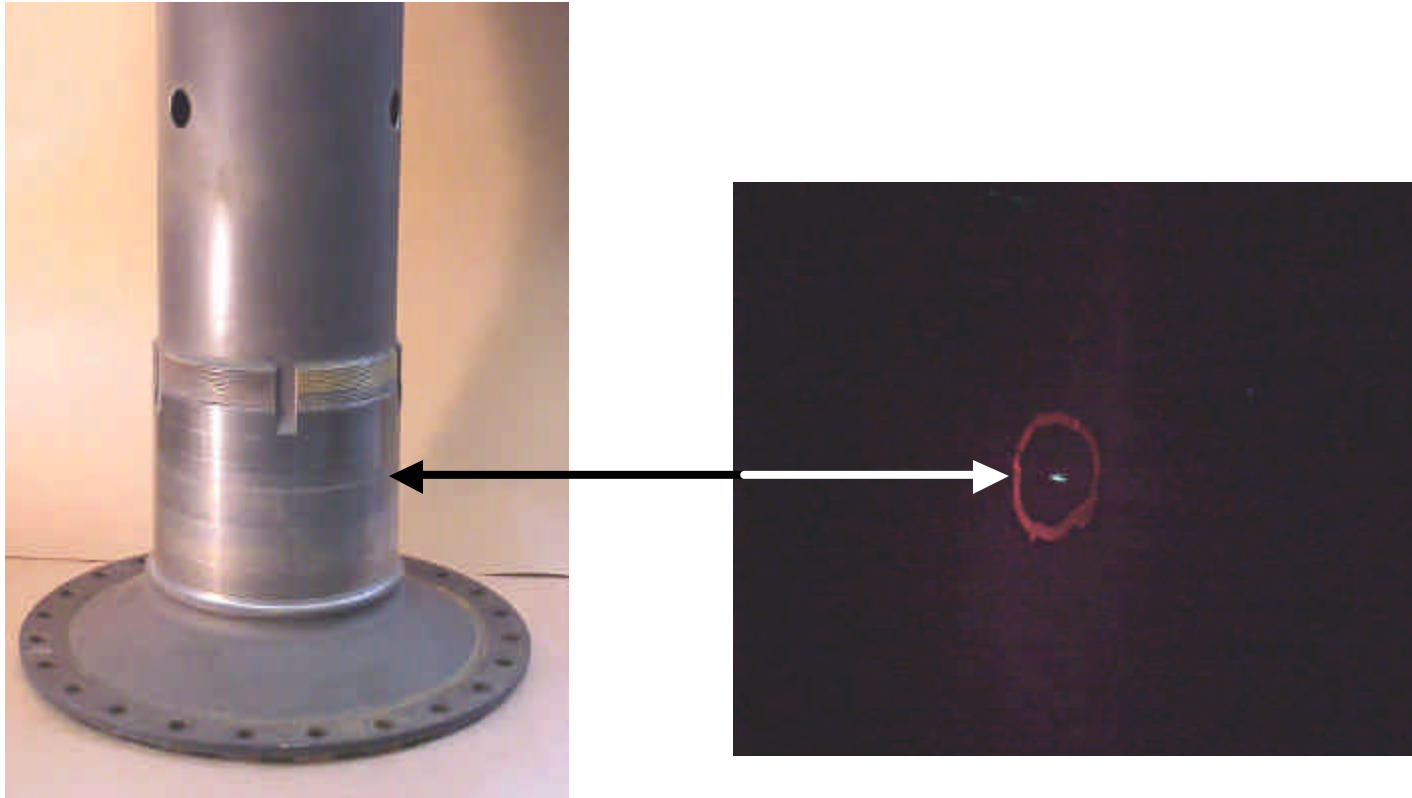
# FPI Coating Indication on the No.5 Bearing Journal

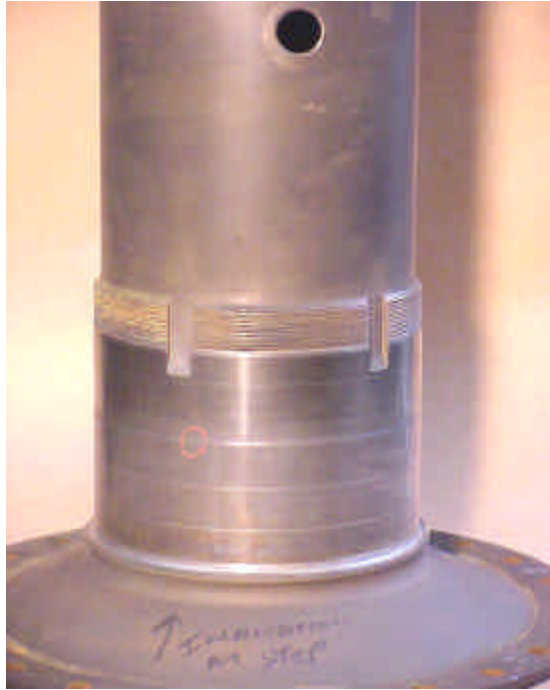
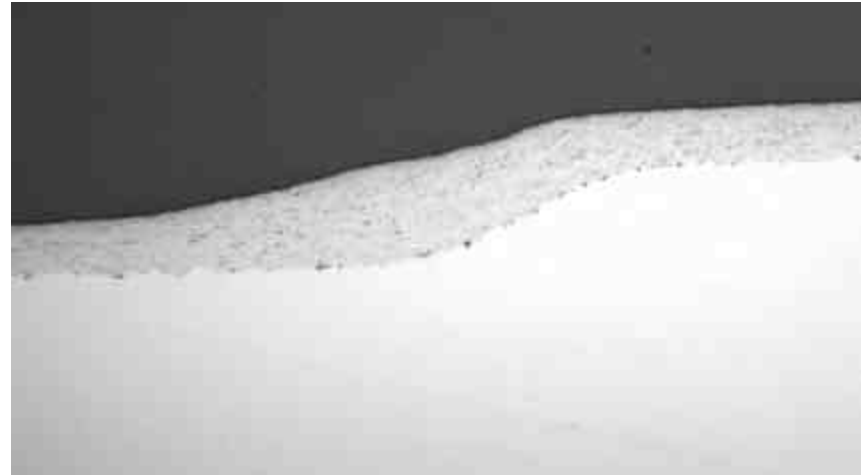
# Metallographic Cross-Section of No.5 Bearing Journal FPI Indication

**No Defect Found**
